## BELZONA PROTECTS NEUTRALIZATION PIT

Neutralization pit.

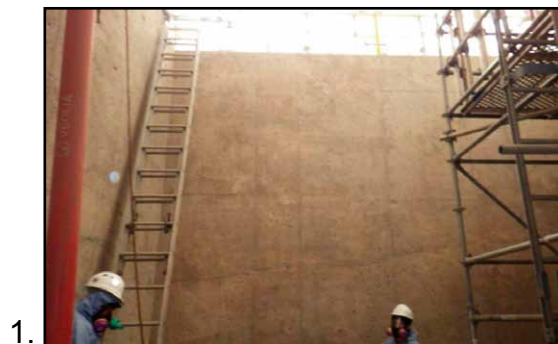
Existing rubber liner had torn, allowing the water, caustic and acid to attack the concrete substrate.

1. Prior to application
2. Rebuilt substrate
3. Application in progress
4. Completed application
