BELZONA PROTECTS PAPER MILL FAN PUMP

Split case pump.

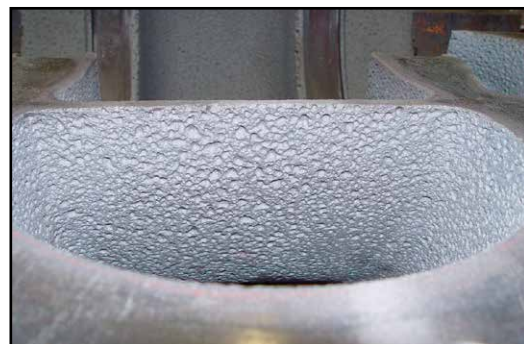
1. Grit blasted, ready to be coated
2. Filling pits with Belzona 1111
3. Coating with Belzona 1391T
4. Completed application to pump casing

The pump was grit blasted. Belzona 1111 was used to fill all the pitting. Two coats of 1391T were brushed on.
