BELZONA REPAIRS AND PROTECTS DAMAGED DRAINS

Floor drain.

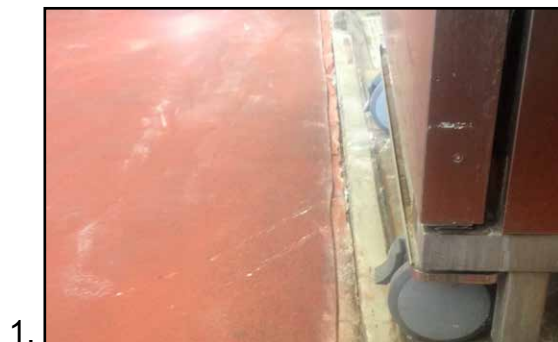
The edges of the floor drain were breaking due to a combination of chemical attack and physical damage.

1. Floor drain prior to application
2. Preparation in process
3. Application in process
4. Completed application
