BELZONA REPLACES FAILED TANK BASE SEAL

Chemical plant, UK

Base of chemical storage tank

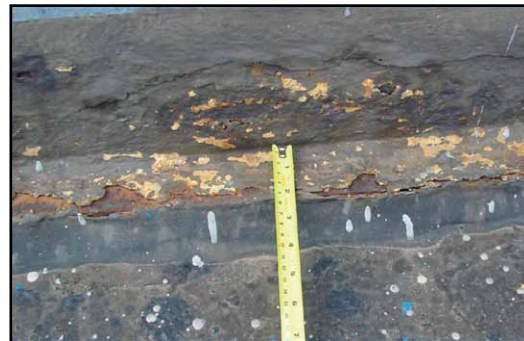
Original seal had cracked and allowed moisture to penetrate beneath tank base. Problem exacerbated by poor water shed leading to external corrosion.

1. Close up showing failure of original seal.
2. Fillet of Belzona® 4131 applied
3. Application of Belzona® 3111 System underway.
4. Application completed.
