BELZONA PROTECTS LARGE COLLECTION TANK

Chemical park, Germany

Underground collection tank for waste surface water

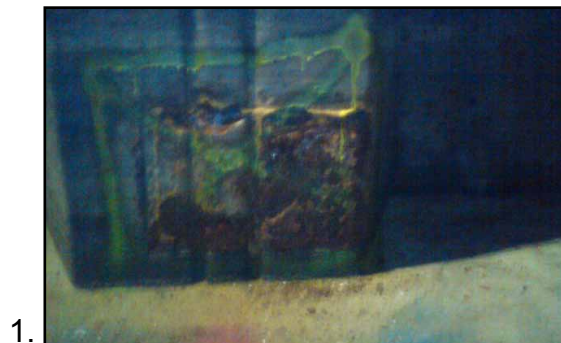
Breakdown of the original coating had allowed corrosion pitting to occur. Some leaks were occurring on the walls, particularly where wall meets the concrete tank floor.

1. Pitting corrosion on tank walls
2. Rebuild and reinforced area with Belzona® 1111
3. Spray-applied second layer of Belzona® 5811
4. Completed application

Application was carried out in accordance with Belzona Know-How System Leaflets TCC-1, TCC-5 & TCC-9. After surface preparation, Belzona® 1111 was used to bond reinforcement steel sheets to areas affected by pitting corrosion. Belzona® 4111 was used to repair damaged areas on the concrete tank base. The entire collection tank was coated with Belzona® 5811 applying two coats by airless spray. Lastly, an elastomeric fillet was created by applying Belzona® 2211 where steel walls joined onto the concrete base.
