BELZONA REFURBISHMENT OF FAN HUB SAVES TIME AND MONEY

Power Plant, Turkey

Cooling Tower Fan Blade case, diameter 1854mm, width 537mm

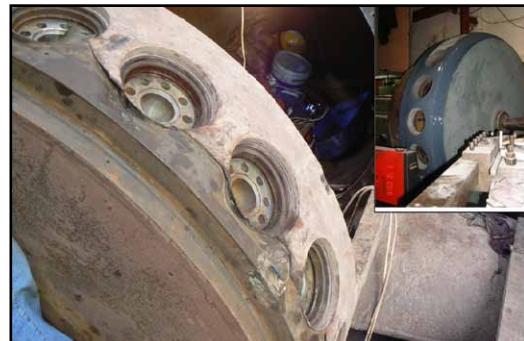
Erosion/Corrosion following failure of previous coating. If allowed to continue could cause severe damage to the fan.

1. Badly corroded case especially bottom side of fan blades
2. Wire mesh and formers cut by CNC used to achieve correct profiles
3. Application of Belzona® 1111 to case with templates in place to form fan pockets
4. Finished application. Rebuild and protective coating applied. Checking each hole by installing fan blade
