## BELZONA REFURBISHMENT MAKES FIRE ESCAPE SAFE

Police Station, UK

Fire escape stairs

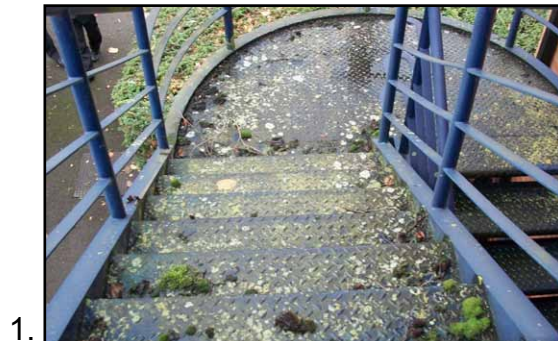
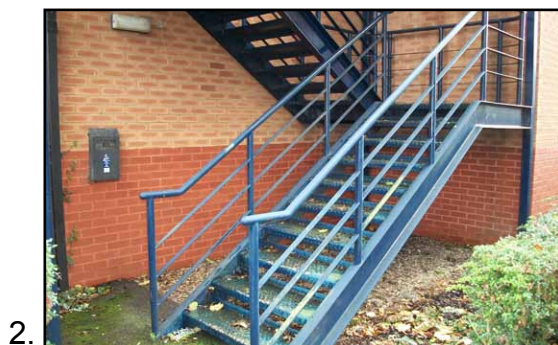
Regular foot traffic and weathering caused the steps of this fire escape to become damaged and worn and had made it a potential slip hazard.

1. & 2. Original condition of the entrance steps
3. & 4. The finished application

Application was carried out in accordance with a modified Belzona Know-How System Leaflet FPA-8. Belzona® 4411 (Granogrip) was applied to the steps with aggregate incorporated in grey and yellow. Belzona® 5111/6111 system applied to the hand rails. Belzona® 1111 was used to smooth out corroded steelwork.
