BELZONA SEALS JOINTS IN UNDERGROUND PIPELINE

Power plant, Western Kentucky

Underground Concrete Pipes from the Cooling Tower to the Condensor.

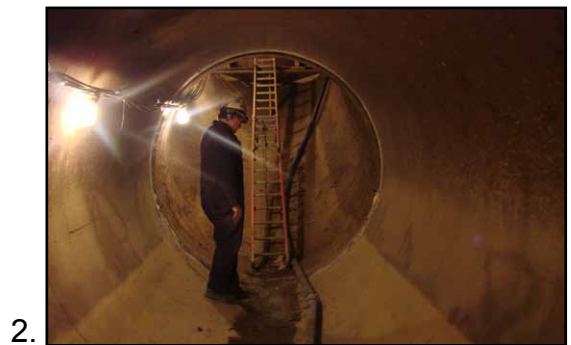
Power Plant was losing the cooling water through the expansion joints at the concrete pipe junctions.

1. & 2. Joints before the application of Belzona
3. Application of Belzona® 2211
4. Completed application

Application was carried out in accordance with Belzona Know-How System Leaflets HEX-13a and 13b. Joints were grit blasted before Belzona® 4111 was used to repair joint edges. Finally joints were sealed with Belzona® 2211.
