## BELZONA GETS COMPRESSOR BACK TO SERVICE IN HOURS

Fertilizer producer, Hungary

CO2 compressor, a key equipment in producing Amide fertilizer.

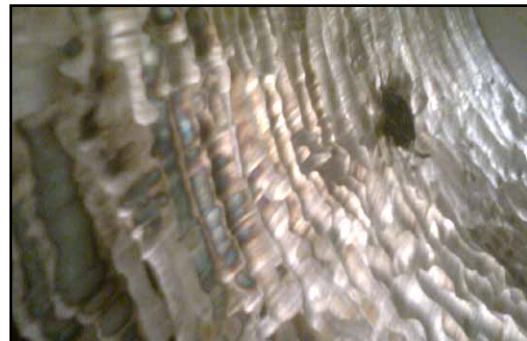
Worn compressors are unable to supply the necessary amount of CO2 into the production line.

1. Worn surface
2. Injecting Belzona® 1321
3. Smooth finished surface after removing former
4. Finished compressor housing
