BELZONA REVISITS LEAKING PIPE

Power Station, Wales

Cooling water pipework

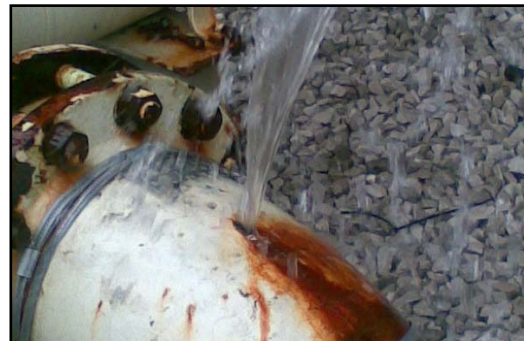
Leaking pipe was affecting efficiency of the cooling system. Back pressure meant repair had to be carried out live and to a very tight schedule. Adjacent section of pipe had previously been repaired with Belzona.

1. The leak
2. Belzona® 1111 wrap completed
3. Completed application protected with Belzona® 1341
4. Note earlier repair immediately below latest repair

Application was carried out in accordance with Belzona Know-How System Leaflet VPF-11a. After temporarily stemming leak with Belzona® 1291, Belzona® 1221 was applied to give additional strength before grit blasting and applying a Belzona® 1111 wrap. Belzona® 1341 was applied over the top to provide corrosion protection to exposed section of pipe.

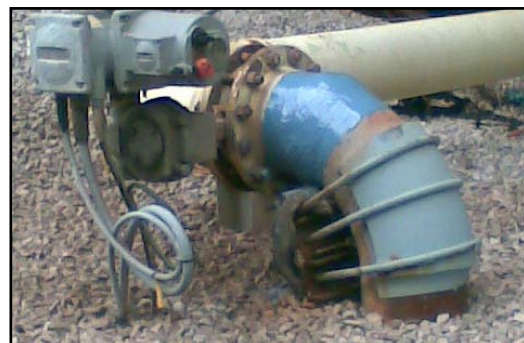
4.

Just 2 hours after completing the repair, the full pressure was restored. This repair has now been in service 3 years with the earlier repair now 7 years in service.
