## BELZONA, THE EASY WAY TO SEAL SILOS

Two 17 metre high, 6 metre diameter silos for storage of Lime and Chalk

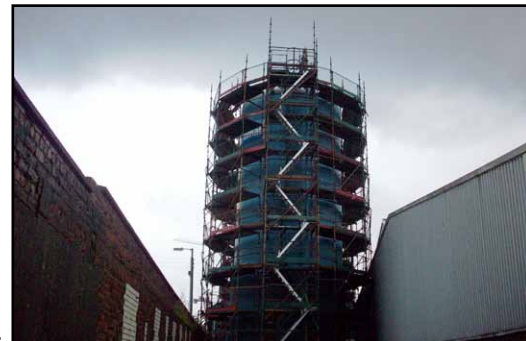
1. Silo scaffolded and ready for work to commence
2. Initial application to problem areas
3. Silo roof fully protected
4. Completed application

Application was carried out in accordance with Belzona Know-How System Leaflet RPA-1. After preparing substrate with grinders, Belzona® 3921 (GSC Conditioner) was applied before completing the application with two coats Belzona® 3111.

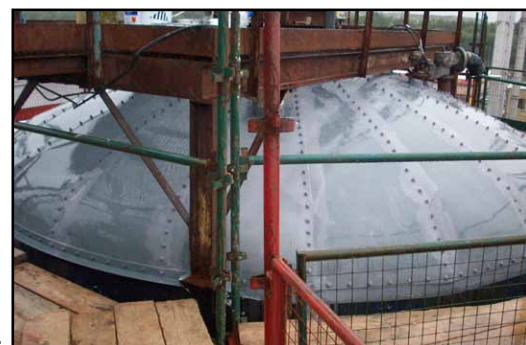
2.

Corrosion and mechanical damage had opened up the bolted joints allowing rain water to wash dirt through the joints leading to contamination of the lime and chalk stored in the silos.
