BELZONA REINFORCES TANK AT STEEL MILL

Steel Mill, North-Rhine Westphalia, Germany

Corrosion of safety immersion tanks in the coke manufacturing plant

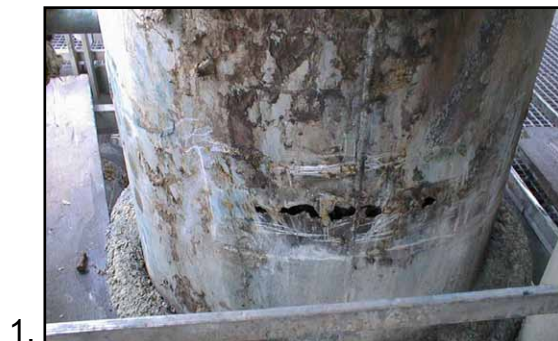
These tanks were damaged around the connection and the walls through the chemical attack of the contained medium (coke gas in water) and local steam. The temperatures ranged from 50°C to 104°C

1. The corroded tank
2. Preparation
3. Fitting the plate
4. Finished application
