BELZONA REPAIR MAKES A RIVETTING STORY

Oil Blender, Duisburg, North-Rhine Westphalia, Germany

Storage tank for petroleum fuels

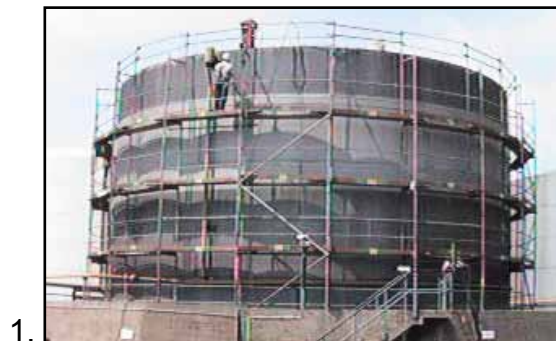
1. Overview of tank
2. Preparation of seams
3. Application of Belzona® 1111
4. Application of Belzona® 1321

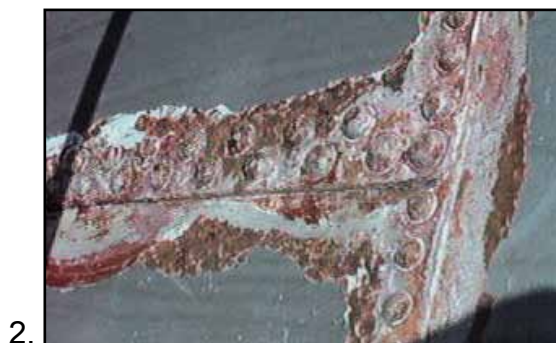
Works were carried out in accordance with Belzona Know-How System Leaflet TCC-1. The leaking areas were prepared initially by wet slurry blasting, as the potentially explosive oil would not permit gritblasting or grinding. Belzona® 1111 was applied followed by Belzona® 9341 (Reinforcement Tape). Two coats of Belzona® 1321 completed the application.
