BELZONA SEALS PLANT ROOM FLOOR

Hospital, UK

Boiler plant room of a hospital

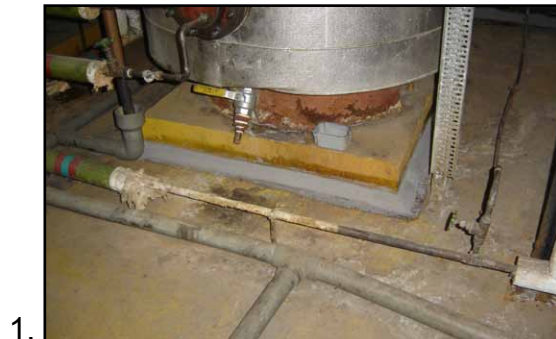
Water was leaking through the floor to the operating theatres below.

1. Damaged floor
2. Belzona® 5231 application starting
3. & 4. Completed application

Application was carried out in accordance with Belzona Know-How System Leaflet FPA-8. The floor was first diamond ground and then two coats of Belzona® 5231 applied.
