BELZONA UPGRADES MORTUARY FLOOR

Hospital Mortuary, Glasgow

March 2008

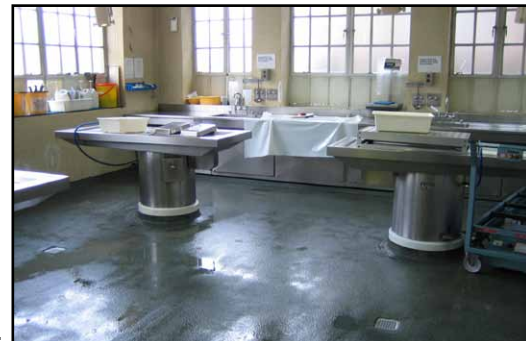
As the floor was regularly washed down, it had caused the floor to become damaged and uneven causing water to gather in certain areas.

1. Damaged floor
2. Examination table base screeded with Belzona® 4131
3. Floor repairs using Belzona® 4131
4. Completed application after application of Belzona® 5231

The customer required the lifting of the existing floor system and repairing the damaged floor areas, followed by an over-coat of a positive grip system.
