## BELZONA OVERCOMES PROBLEM OF LEAD THEFT

Local School, UK

Window canopies on roof of a local school

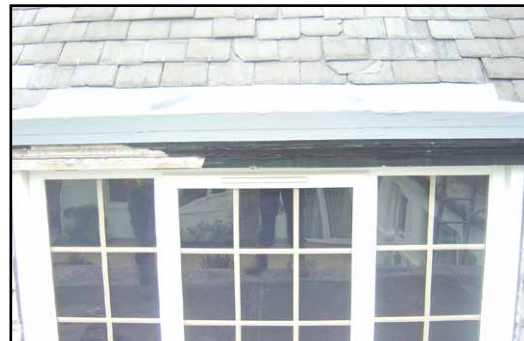
This school had recently suffered from theft of the lead from their roof. The damage was so extensive that if not addressed, it would lead to structural defects resulting in a potentially disruptive high cost maintenance repair.

1. Window before application
2. General view of the roof
3. Application completed
4. Application completed

Application was carried out in accordance with Belzona Know-How System Leaflet RPA-2. Roof was felted prior to sealing with fully reinforced Belzona® 3111 system.

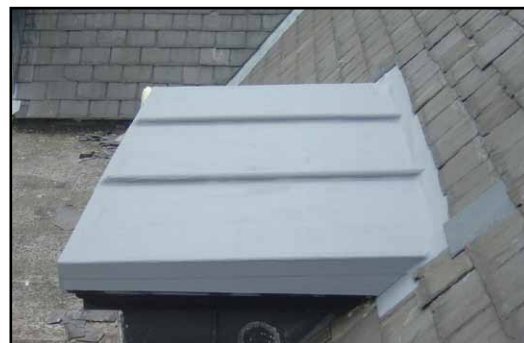
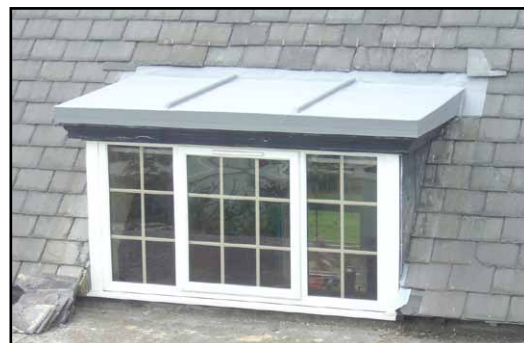
The repairs were completed in less than one week. Revisiting the application in 2010, the school has not experienced any further problems, and the repair is still in excellent condition.
