BELZONA REPAIRS SCHOOL WALKWAY

Regional Council Primary School, UK

Asphalt covered concrete cantilever walkway.

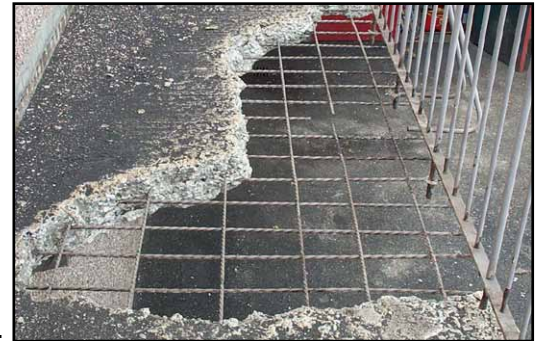
Regular application of salt had led to deterioration of the concrete beneath the asphalt. When asphalt was removed, a major structural issue was uncovered. The structural engineers at the council gave the approval for the repair.

1. Severity of damage revealed after grit blasting
2. Application of Belzona® 4131 completed
3. Application of Belzona® 5231 to entire walkway
4. View of application after 9 years

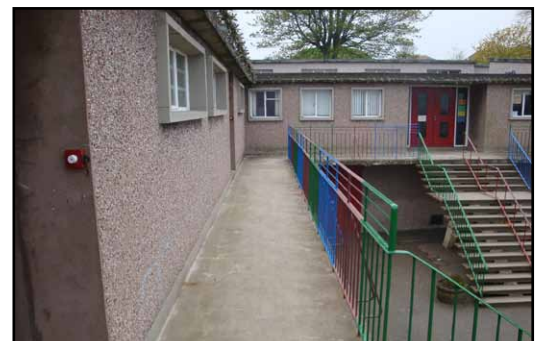
4.

Alternative: Knock it down and replace it with a steel fabricated platform to strengthen the whole building. Benefit: Work was completed during summer holidays and local authorities were delighted due to the major cost savings estimated to be around £20k minimum. Recent (2011) examination showed application to still be in excellent condition.
