BELZONA REPAIRS COLOUR MATCH SPALLED LINTELS

Local Education Authority, UK

Concrete lintels.

Spalled concrete due to rebar corrosion.

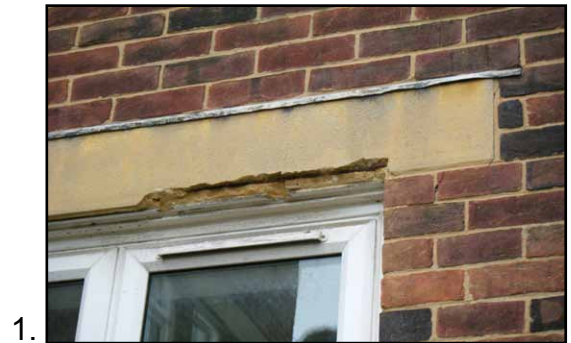
1. Spalled concrete.
2. Application in process using straight edge to form neat corner.
3. Completing the application.
4. Completed application. Note excellent colour match.

Application carried out in accordance with Belzona Know-How System Leaflet WPA-4. Belzona® 4141 was colour matched to existing concrete using Iron Oxide pigments.

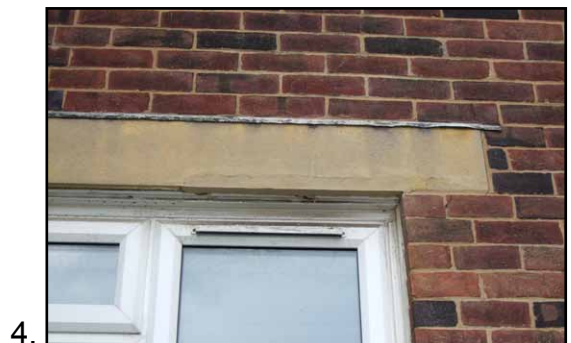
Repair was carried out quickly without need for scaffolding or permanent shuttering. Ability to colour match the repair ensured aesthetic acceptability.
