BELZONA REPAIRS ROOF AT PRESTIGIOUS UNIVERSITY

University Library, UK

Summer 2010

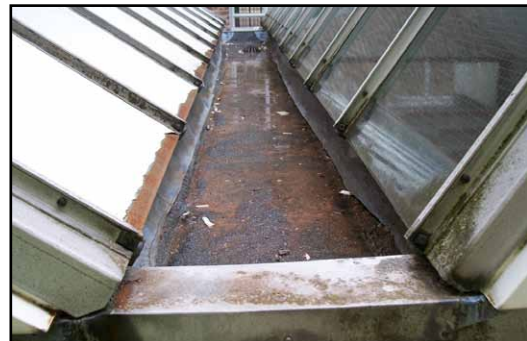
The mineral felt roof and gutters were in poor condition with various areas leaking directly into the reading room below where many historic books are stored and read daily by students.

1. Damaged gutter prior to the application
2. Gutter coated with Belzona® 3111
3. Leaking roof area
4. Roof coated with Belzona® 3111
