BELZONA RESTORES SCHOOL TOWER

Primary School, UK

Two stone towers connected with a wrought iron construction at the top of an old school building.

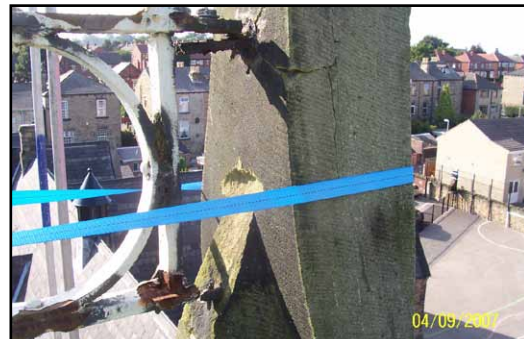
Cracking and spalling of 2 stone towers and corrosion of connecting wrought iron metalwork created a Health & Safety risk.

1. The problem
2. Stone removal
3. Completed rear tower
4. Completed work
