BELZONA UPGRADES FLOOR IN FOOD PREPARATION AREA

School, UK

Floor in food preparation area.

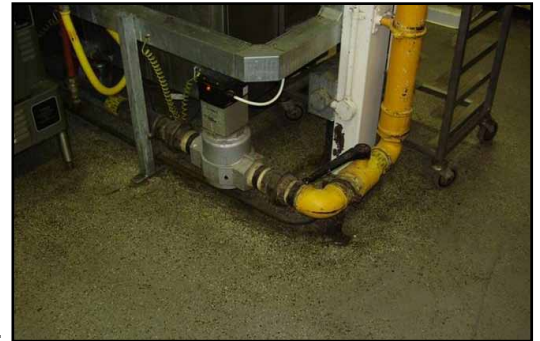
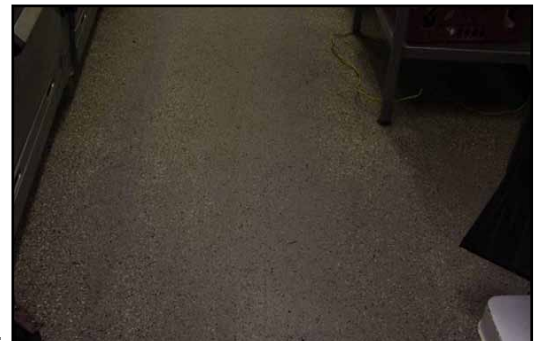
The floor was slippery creating a health and safety issue. In addition the concrete was being damaged around drains.

1. & 2. Floor Problem Area
3. & 4. Completed Floor Application

The application was carried out in accordance with Belzona Know-How System Leaflet FPA-3. The concrete was abraded to remove the existing coating before applying the 2 coat Belzona® 5231 system by roller.
