## BELZONA SEALS TANK AT CABLE MANUFACTURER

Welded seam, oil storage tank.

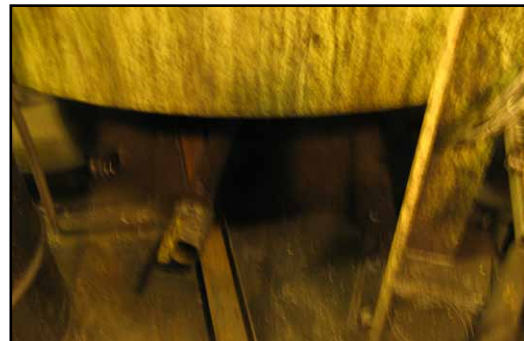
1. Exterior of tank
2. Pitted bottom after cleaning and blasting
3. Belzona® 1111 seals welds and holes
4. First coat of Beige® 5811 applied

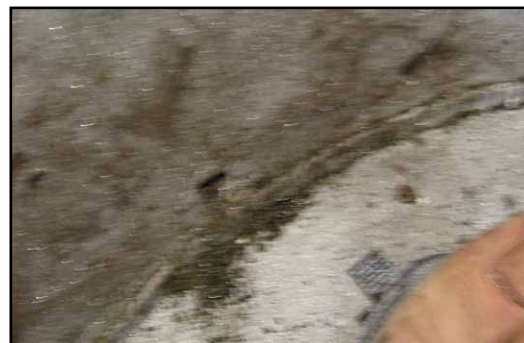
2.

Interior bottom cone of tank was leaking resulting in safety issues. severe corrosion pitting present particularly at the welded seams.
