## BELZONA RESTORES HYGEINE IN BOTTLING ROOM

Bottled Water Manufacturer, Perthshire, UK

Tiled floor in bottling room.

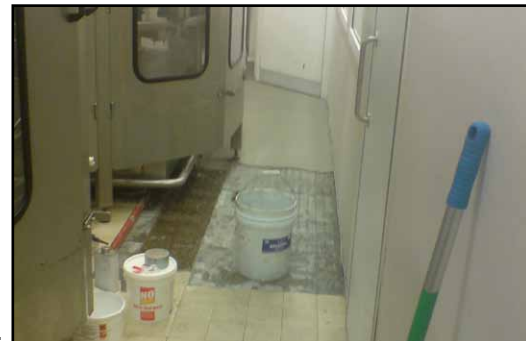
There were several cracked and broken tiles. This created a potential hygiene problem and required rectifying to remove traps for bacteria and to aid cleaning.

1. Damaged tiles being repaired with Belzona® 4131
2. Floor levelled with Belzona® 4131
3. Light grey Belzona® 5231 being applied
4. Completed floor coating

Application was carried out in accordance with Belzona Know-How System Leaflets FPA-1 & 3. Belzona® 4131 was used to replace loose tiles and create a uniform surface prior to application of the Belzona® 5231.
