## BELZONA PROTECTS KORT NOZZLES

Tug boat operator, Egypt

Pair of kort nozzles on tug boat

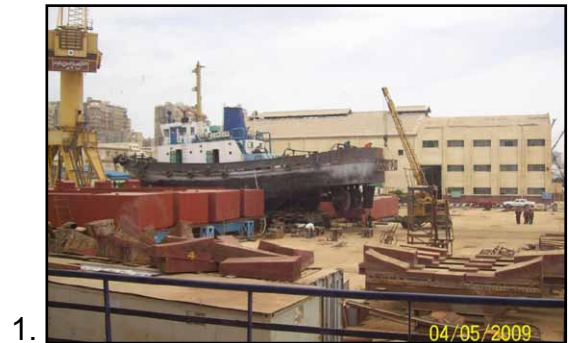
1. The boat in dry dock
2. Grit blasting the nozzles
3. Applying of Belzona® 1321
4. Completed application

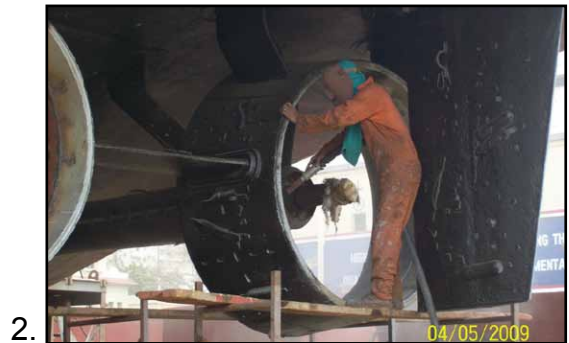
The Kort nozzles were suffering badly from erosion corrosion.

Application was carried out in accordance with Belzona Know-How System Leaflet SOS-2.
