BELZONA SUPERWRAP SEALS WEEPING STORAGE TANK

220 foot diameter 56 foot high storage tank containing fuel oil at 140°F max. temperature.

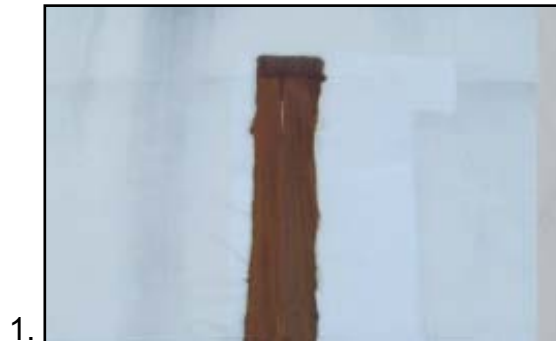
Vertical weld was found to be very porous and fuel oil was weeping from a 2 mm through wall defect. No corrosion or thin wall area was detected. Defect was located at 30 feet from the ground level.

1. Damaged area
2. Area prepared by abrasive blasting
3. Belzona® SuperWrap Application
4. Belzona® SuperWrap repair inspected and painted over
