## RESEATING NEW RUDDER BEARING WITH BELZONA

Dockyard, Bulgaria

Installation of new bronze bearing in oversized bearing housing.

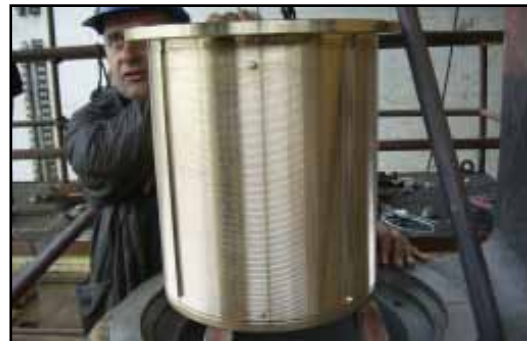
1. Bronze bearing machined and ready to be inserted in to the housing
2. Centralizing of the bearing in progress
3. Bae of bearing sealed with Belzona® 1221
4. Finished application after injection of Belzona® 1321

Application was carried out in accordance with Belzona Know-How System Leaflet SOS-9. The injection was through flexible hose placed into the four channels made in the back of the bearing.
