BELZONA REPAIRS KAMEWA IMPELLER DUCT

Kamewa jet drive on high speed passenger ferry operating on lake Como

Deep erosion on the impeller duct lining

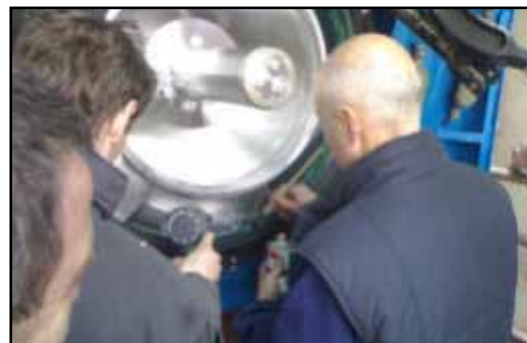
1. View of the high speed ferry
2. Conditioning the substrate underway
3. Close up of the application
4. Completed application

The application was carried out in accordance with Belzona Know-How System Leaflet TCC-3.
