BELZONA OVERCOMES ROOF DESIGN FLAW

River Dam Authority, Vinita, OK

August, 2005

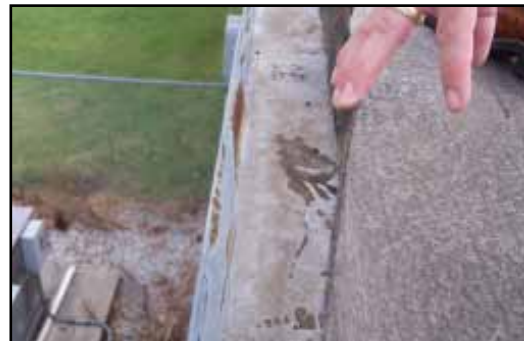
A small collection trough around the 660' perimeter of the roof had mistakenly been "engineered" into the original installation. Water collected and eventually drained under the roof sheets toward the center of the building until it found a leak path onto the ceiling.

1. The poor roof design allowing water to collect and enter
2. Conditioning of metal trim and roof sheet
3. Belzona® 3111 being applied through the Reinforcing Sheet
4. Completed application with entire building perimeter sealed with Belzona Membrane System
