## BELZONA REBUILDS SEAL FACE ON RAW MILL AT CEMENT PLANT

Cement Plant, Nazareth, Pennsylvania

Rotating table of grinding mill for raw materials used in the production of cement.

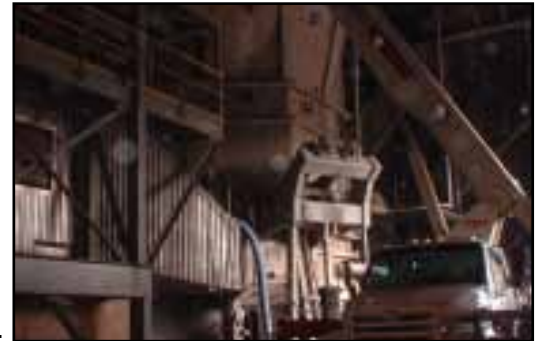
1. Raw mill overall size
2. Worn seal area on rotating table
3. Belzona® 1812 applied and new felt seal and holder installed
4. Another general view of the mill

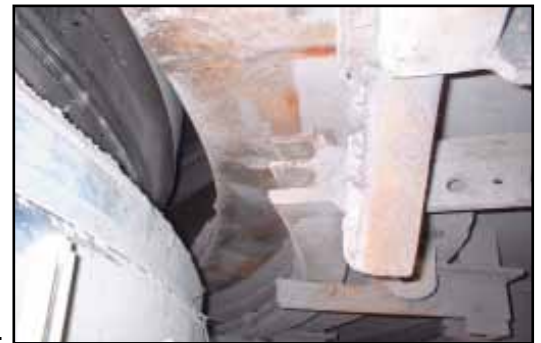
2.

Abrasion from the felt seal and limestone wore this major component of the mill.

Application was carried out in accordance with Belzona Know-How System Leaflet SHM-13. Limited access only allowed hand grinding for preparation followed by application of the Belzona® 1812 by trowel.
