BELZONA CORRECTS HATCH SEALS

Ship Dockyard, Bulgaria

New rubber seals for cargo ships hatch covers.

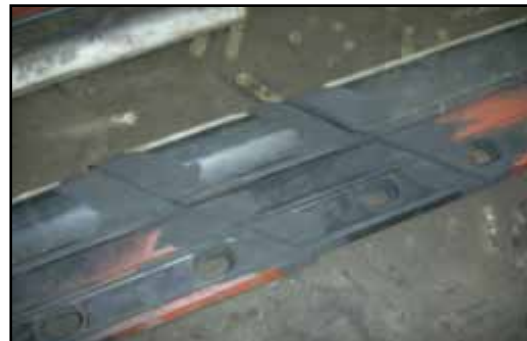
1. The three pieces altogether to give the correct length for each seal
2. Application of Belzona® 2211 on the joints kept together with metal templates and clamps
3. The assembly after application
4. Mounting of the repaired seal to the cargo hatches

Application was carried out in accordance with a modified version of Belzona Know-How System Leaflet SHM-3. Each rubber seal was cut at angle of 45 degree and between two parts the additional piece to correct the length was inserted. For better joint strength additional rubber strips were cut and bonded inside of the hatch seal pieces. All pieces were assembled and kept together by help of metal templates and clamps until complete cure of the applied Belzona® 2211.
