BELZONA RESEATS BEARING BUSHES IN STEERING GEAR

Two bronze bearing bushes within the Rudder steering system of cargo ship.

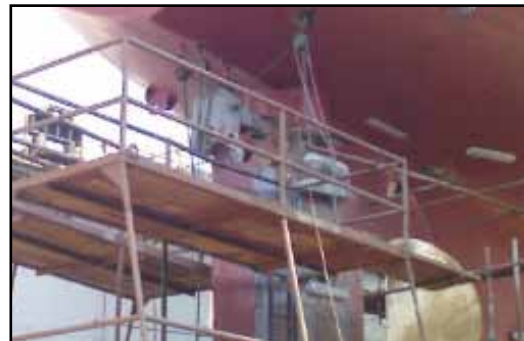
1. General view of the rudder steering system
2. Close view of the worn housing after blasting
3. Reseating of the new bronze bush at the exact position
4. Injection of Belzona® 1321 through injection ports in side flanges completed

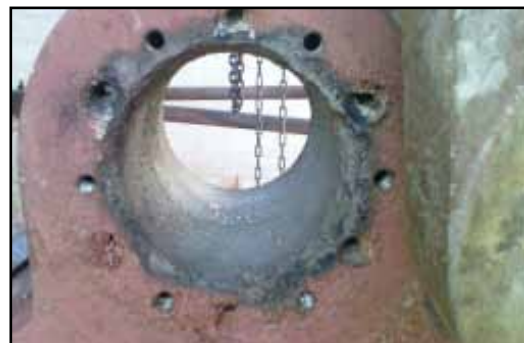
2.

Bimetallic corrosion caused wear of bush housing with further damage caused by the increased vibration in the rudder steering system.
