## BELZONA EXTENDS LIFE OF MIXER BOWLS FROM ENGINE CASTING PLANT

Engine casting plant, Windsor, Ontario

Mixing containers used to blend silica sand and phenolic resin, the result of which is then used to make V6 engine casings for international automobile manufacturers.

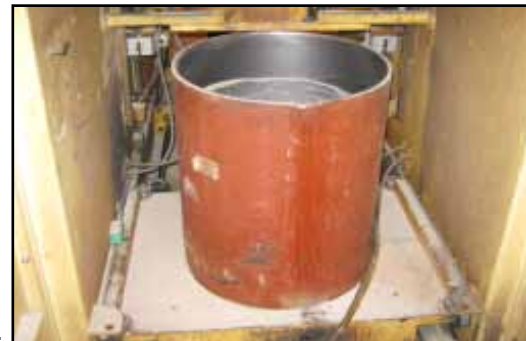
1. Working mixer bowl
2. Inner bore of worn mixer
3. New mixer bowl after machining
4. Completed application of Belzona® 1812

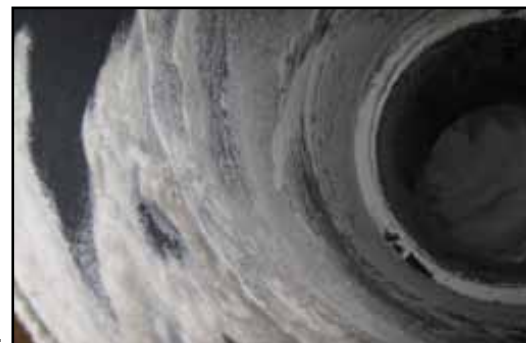
Inside surface of bowl was being eroded by the sand mixture. The bowl measures approximately 19 inches in diameter by 27 inches in length. The inner surface was being eroded by 1/4 inch during a 6 month period. The mixers handle up to 5.5 tonnes of sand per hour.

Application was carried out in accordance with Belzona Know-How System Leaflet SHM-13. The inner surface was machined to remove approximately 3/16 of an inch of material to allow for build up of Belzona® 1812 which was applied by hand using top flange and lower wear plate to control thickness.
