CHIMNEY SHINES WITH BELZONA PROTECTION

Powerstation, Poland

120m high Powerstation chimney

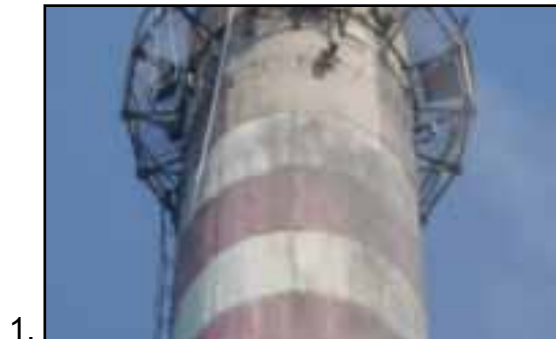
The existing coating systems had reached the end of their life and broken down resulting in an unattractive and poorly protected chimney stack. The client undertook a comparison of Belzona with a competitor.

1. September 2008 pre works
2. Application underway via rope access
3. Completed application
4. The top two, shiny bands are Belzona® 5111
5. Review in 2010 - note the top two bands are still shiny

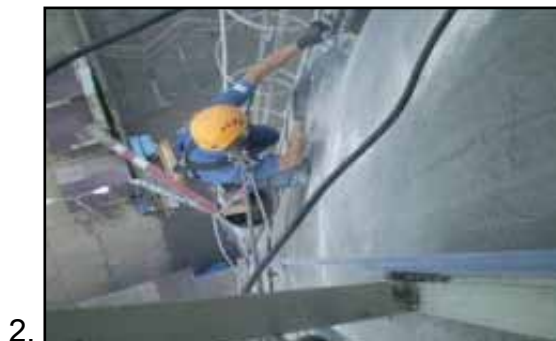
Application was carried out in accordance with a modified Belzona Know-How System Leaflet WPA-2. Rope Access Technicians were used in place of industrial scaffolding. The top two, most aggressively attacked bands were coated using Belzona® 5111 in red and white.

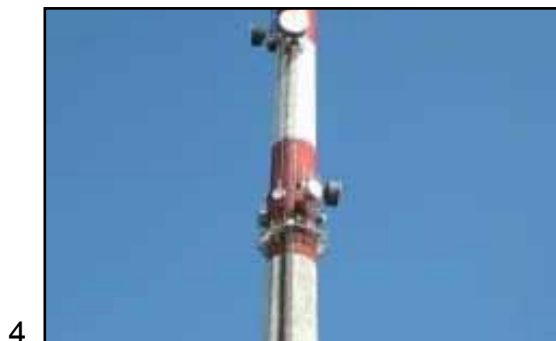
After initial review it was noted that the Belzona® 5111 quite literally outshone the competition. Aside from the chemical and UV resistance needed for the application, the smooth surface of Belzona® 5111 did not attract dirt and would "self clean" with rain.
