BELZONA REPAIRS AN AUGER SCREW

Chemical fertilizer producer, Tunisia

Large screw auger handling Phosphate fertilizer.

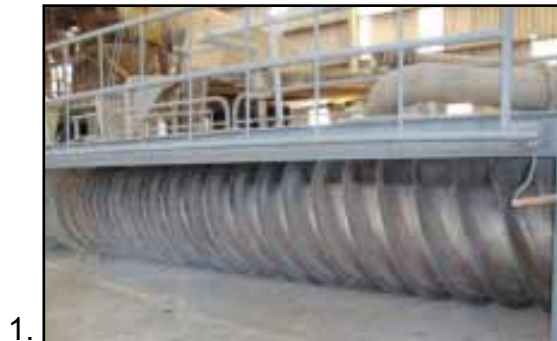
The weld area between the flights and auger shaft had been severely eroded due to the abrasive and corrosive nature of the phosphate. This erosion damage was around 20cm wide and spread over the length of the equipment.

1. Grit-blasted auger screw
2. Application of Belzona® 1811
3. Finished application

The application was carried out in accordance with Belzona Know-How System Leaflet SHM-14. The equipment was grit-blasted, degreased, then the eroded areas covered with 40kg of Belzona® 1811.
