BELZONA RESTORES CRITICAL TOLERANCES IN LIQUID RING VACUUM PUMP

Paper mill, Australia

December 2005

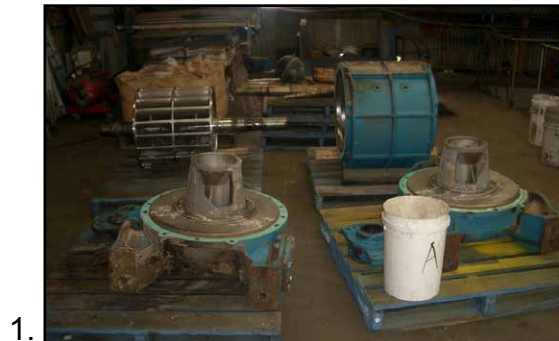
1. A dismantled vacuum pump from Paper Mill
2. Cone from 14,000 CFM vacuum pump undercut prior to the application
3. The stainless steel cone repaired with Belzona® 1111 after 4 years in service
4. The stainless steel rotor is showing significant wear, whereas the Belzona® 1111 applied to the adjacent cone is not

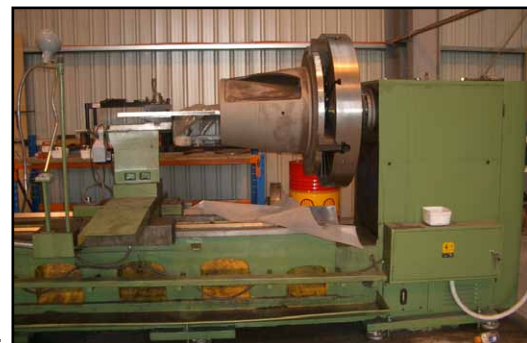
2.

The pump is subjected to corrosion and “carry over” of the paper pulp. The tolerance between the outside diameter of the cone and the internal taper of the rotor was no longer correct, due to the wear on the cone flange, clearly visible near the bolt holes.

Application was carried out in accordance with Belzona Know-How System Leaflet FBC-10. The stainless steel cone in this pump was rebuilt with Belzona® 1111 and machined to correct dimensions and taper angle.

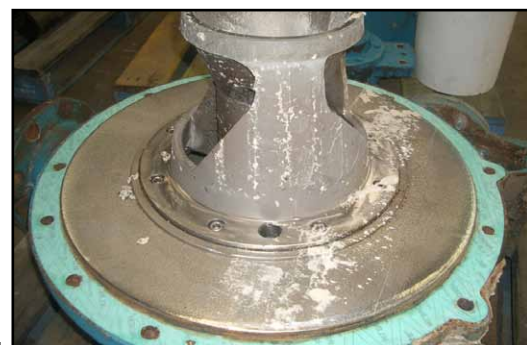
3.

The pump cone was inspected after 4 years in service. Despite the aggressive conditions, the Belzona® 1111 is showing virtually no wear. The stainless steel rotor is showing significant wear whereas the Belzona® 1111 applied to the adjacent part (the cone) is not.
