## BELZONA COMBATS A MAJOR VACUUM PUMP WEAR PROBLEM

Paper mill, Australia

2002

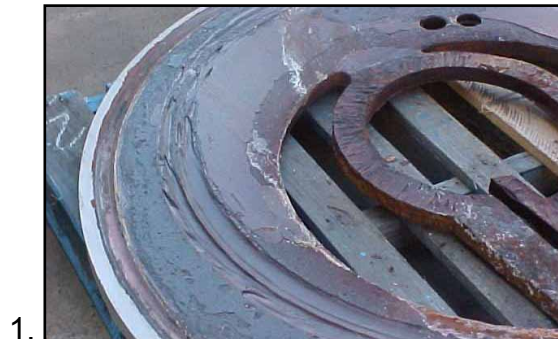
A pump was removed from service and inspected. On dismantling the pump, it was found that excessive "carry over" from the process had caused major erosion and corrosion damage to the pump components and the critical tolerances had been lost.

1. Worn port plate
2. Worn head
3. Port plate completed
4. Rotor completed

The first pump was repaired and protected with Belzona in late 2002 and placed back into service. In December 2003, an internal inspection of the pump proved the Belzona material was completely intact and was providing complete protection of the pump. It should be noted that no change in the process had occurred and an unprotected pump was almost destroyed in less than 12 months. The "Belzona treated" pumps remained in service for approximately 6 years before requiring another overhaul and no pumps have required replacement. In this case, Belzona is providing a pump service life 6 times longer than a new pump.
