BELZONA ELASTOMER MAKES MECHANICAL SEAL REFURBISHMENT EASY

Hydroelectric plant, Italy

Mechanical Seal from hydroelectric turbine

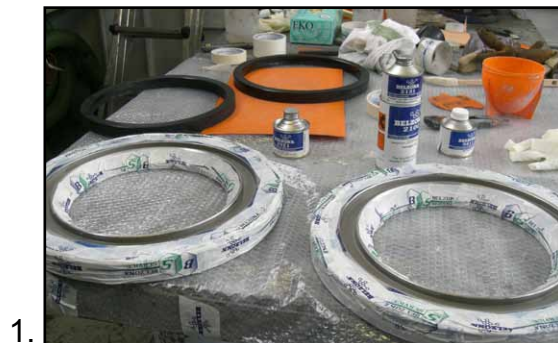
1. Protecting and blasting steel support
2. Rubber ring being Conditioned
3. Conditioner applied to metal support
4. Rubber ring bonded in place with Belzona Elastomer

Application carried out in accordance with Belzona Know-How System Leaflet GSS-2. Rubber ring bonded in place with Belzona® 2111 then re-machined to precise tolerance. Steel substrate is masked off and bond face grit blasted prior to bonding rubber ring in place with Belzona Elastomer.
