LONG TERM ROOF REPAIR BY BELZONA

Old private villa, Italy

Asbestos tiled roof of an old villa.

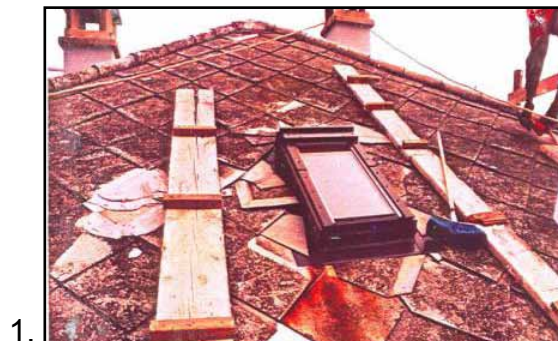
Severely deteriorated asbestos roof tiles were no longer providing weather protection.

1. Damaged roof in 1985
2. Roof application after 10 years in service
3. Close-up after 10 years in service
4. Refurbishment in 2008 again with Belzona® 3111

Application was carried out in accordance with Belzona Know-How System Leaflet RPA-1.

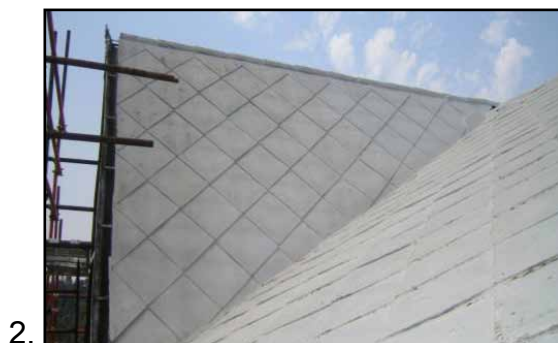
After 10 years in service, the application was reviewed and still found to be in an excellent condition. Due to the reliable performance of Belzona, the customer opted again for Belzona® 3111 to refurbish the roof after 23 years service.
