BELZONA REPAIR AND PROTECTION OF SEA WATER LIFT PUMPS

Pump repair workshop, Norway

Sea water lift pumps.

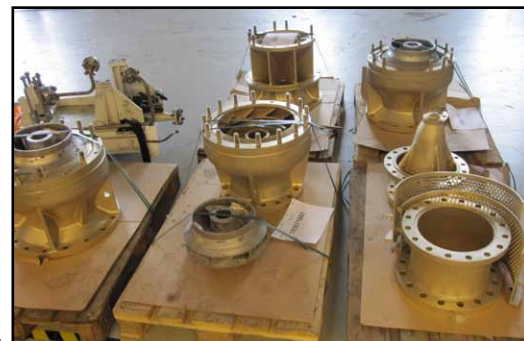
Pumps and various assembly parts were suffering from erosion and corrosion.

1. Application parts overview
2. Close up of corroded surface
3. Rebuilding with Belzona® 1311
4. Complete application with 2 coats of Belzona® 1341
