BELZONA REPAIR TO PUMP SHAFT BEARING SURFACE

Power Station, South Wales

August 2010

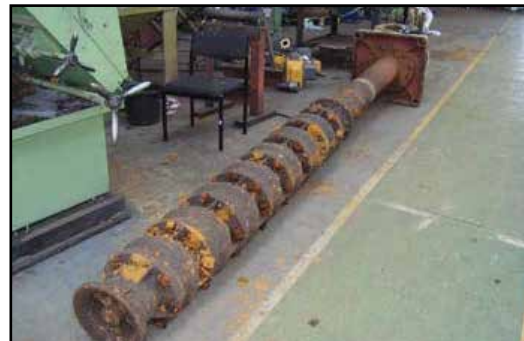
Main cooling water pump at Power Station. The back up pump was the only pump supplying cooling water to the Power Station meaning the reserve pump had to be fixed immediately.

1. Pump waiting to be dismantled
2. Damaged area on shaft clearly visible
3. First machine cut being applied to Belzona® 1131 rebuild
4. Completed repair ready for pump re-assembly

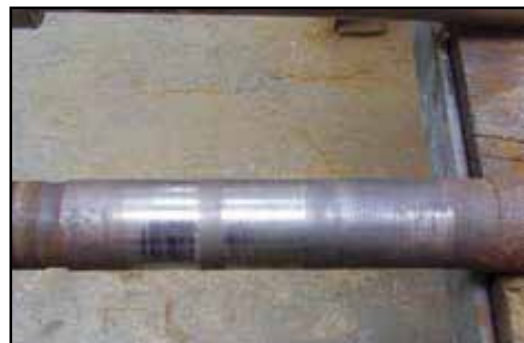
2.

Damage had occurred to the drive shaft of the pump. Previously repaired using hot metal spraying which caused 'pick up', the customer required a fast repair.
