BELZONA SEALS LEAKING CAUSTIC TANK

Drinks Manufacturer, North London

November 2011

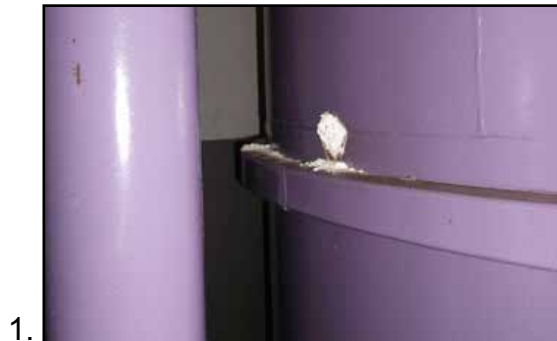
The caustic tank used as part of the process had sprung leaks along the weld seams.

1. Caustic leaking from weld seams
2. Surface preparation using MBX Bristle-blaster
3. First layer of Belzona® 1111 being applied incorporating Reinforcement Tape
4. Finished application
