BELZONA REDUCES SLIP RISK ON SCHOOL STEEL WALKWAY

School, Derbyshire, UK

An external steel chequer plate walkway within a school courtyard.

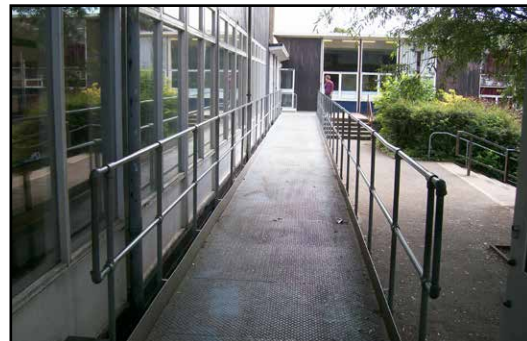
The chequer plate had become polished over time by regular foot traffic by the pupils and staff and was posing a significant slip risk to all who used it. The walkway was also used by wheelchair bound pupils and a positive grip was essential for their safe passage.

1. Situation prior to application
2. Preparation in progress, marking out of application area
3. Belzona® 1821 being applied directly followed by Belzona® 9221 surefoot aggregate
4. Completed grip system
