BELZONA SEALS TRANSFORMER LID FLANGE

Lid gasket flange on this 66-11Kv transformer.

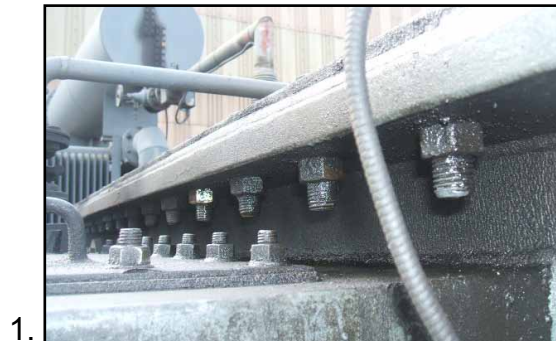
Most of the gasket had failed around the 10m perimeter of the lid, with oil seeping down the sides and going to ground. Unfortunately it was not possible to drain the oil below the gasket level and so the application had to be pursued as a live leak with a 1m head pressure.

1. Original condition of flange with header tank at rear
2. Encapsulation of bolts with Belzona 1161
3. Completed repair close up
4. Finished work after 3 days

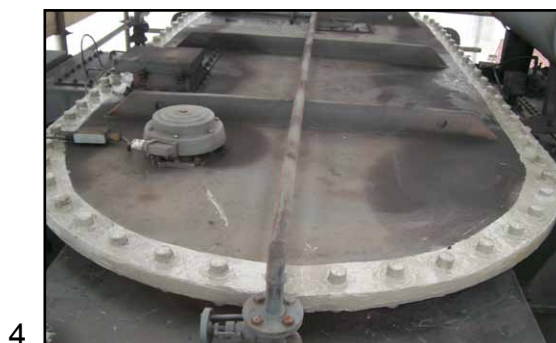
The customer was desperate for a fast solution to the problem and whilst there were a couple of very minor leaks still on completion, these were deemed to be well within acceptable limits. The customer was delighted with the results and is looking to repeat the application to other transformers on their site.
