BELZONA PROTECTS AUGER SCREWS AT CEMENT PLANT

Cement Producer, Lithuania

Coal transporter at cement plant.

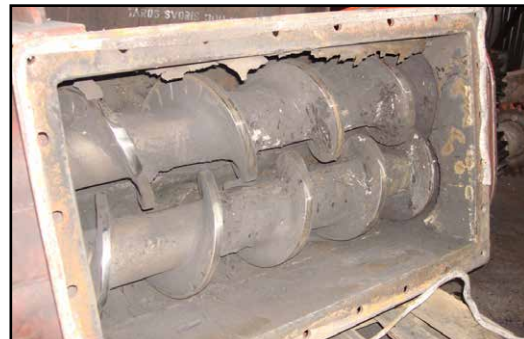
The auger screws suffer severe abrasion and client needed an effective protection system.

1. General view of screws after 1 year in service
2. The view after surface preparation
3. Belzona® 1812 application on both sides of helical outer surfaces
4. Belzona® 1321 application and completed job
