BELZONA SEALS ROOFTOP EXPANSION JOINTS

University, Leeds, UK

Pond on roof of university

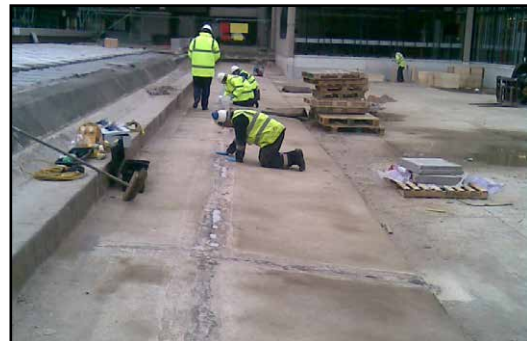
Pond had been drained for refurbishment and concern was expressed over the waterproofing of the expansion joints.

1. Roof showing signs of damage
2. Close up of the damage
3. Application in progress
4. The application completed
