BELZONA REPAIRS LEAKING HEAT EXCHANGER TUBE SHEETS

Various oil & air coolers of marine vessel

Severe erosion and galvanic corrosion between copper tubes and steel tube sheet.

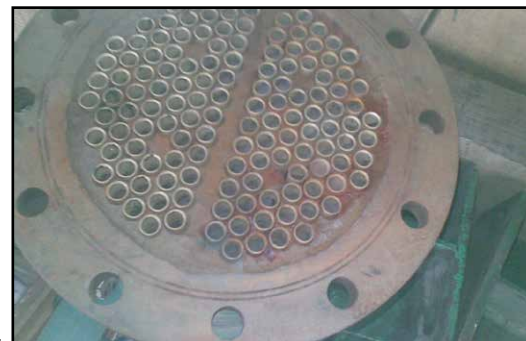
1. The severe damage clearly evident
2. After grit blasting, the eroded tube sheet was rebuilt with Belzona® 1311
3. The coolers after application of Belzona® 1321
4. Further air coolers were also repaired
