BELZONA SEALS HEAT EXCHANGER AT METHANOL PLANT

Heat exchanger with temperature around 150°C used in the Methanol process.

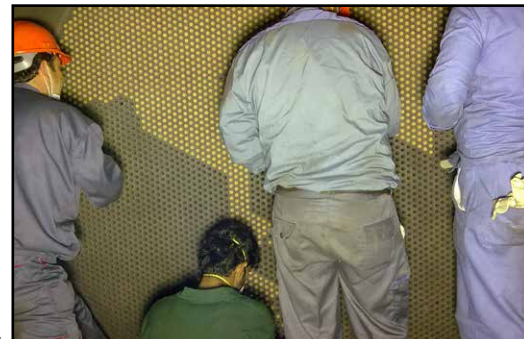
1. Workers corking the tubes
2. Close up
3. Tube sheet face rebuilt with Belzona® 1511
4. Completed application after removal of corks
