BELZONA RESTORES SAFETY TO FIRE ESCAPE STAIRWAY

Water Supplier, UK

Smooth concrete fire escape stairway

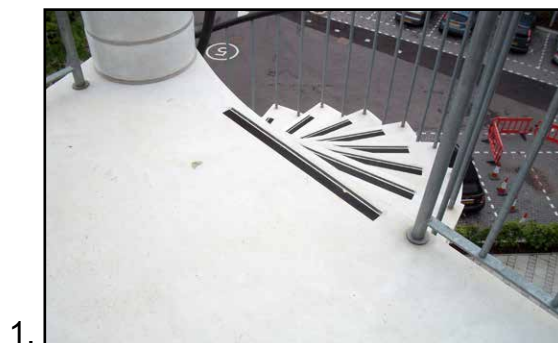
The concrete steps had worn and the current safety grip system had become almost none existent due to heavy foot traffic and weathering. A member of staff had slipped down the steps and injured themselves so solution to this serious slip hazard required.

1. Staircase prior to application
2. Surface prepared ready of application
3. Completed Application
4. Completed Application
