BELZONA REPAIR AND PROTECTION OF HYDRO PLANT DRAFT TUBE

Hydroelectric power station, north Sweden.

Hydroelectric power plant draft tube.

Severe damage caused by cavitation in the upper part of the draft tube.

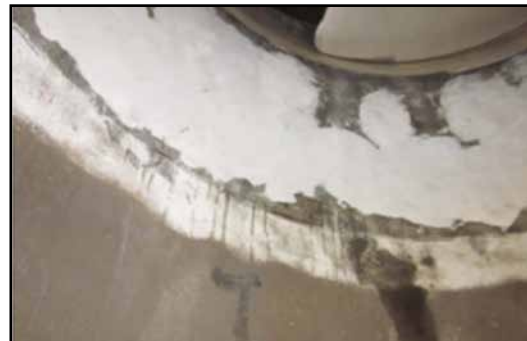
1. The draft tube being repaired with Belzona® 4111
2. The repair area being coated with Belzona® 1341
3. The finished application
4. The application one year later

Application was carried out in accordance with Belzona Know-How System Leaflet CEP-10. After drying and preparing substrate Belzona® 4111 was used to rebuild damaged concrete before coating with Belzona® 1341.
