## BELZONA UPGRADES SPIRITS CONTAINMENT AREA

Distillery, Scotland

Spirit containment area

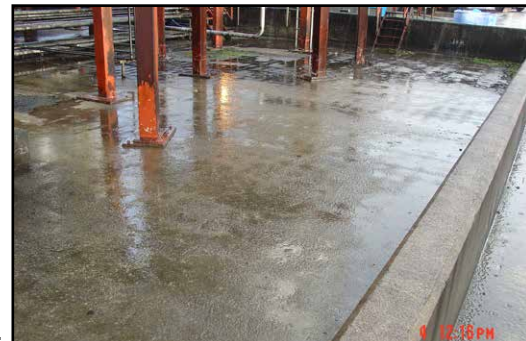
1.

The existing protective system had failed. The chemical containment area could no longer be relied upon to prevent liquid loss into the groundwater/watercourse in the event of a spillage.

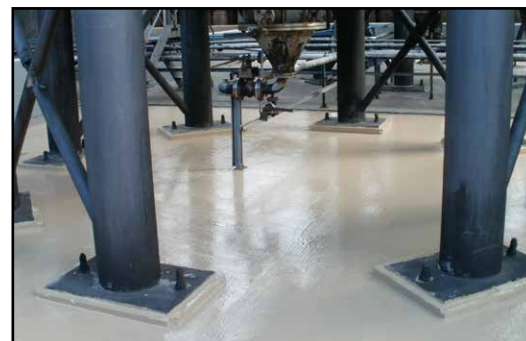
4.

The Belzona system provides excellent resistance to permeation. The reinforcement of wall and floor joints will ensure long term containment without cracking or breaks in the bund lining.
